# SAFETY ALERT

## Product Safety Bulletin No. 2

It has been reported that the bolts that retain the Grabber Cylinder Retaining Plate have fallen out and allowed the plate to fall.

GDM Top Drive 500/650 Ton and GDM Top Drive 750/850 Ton

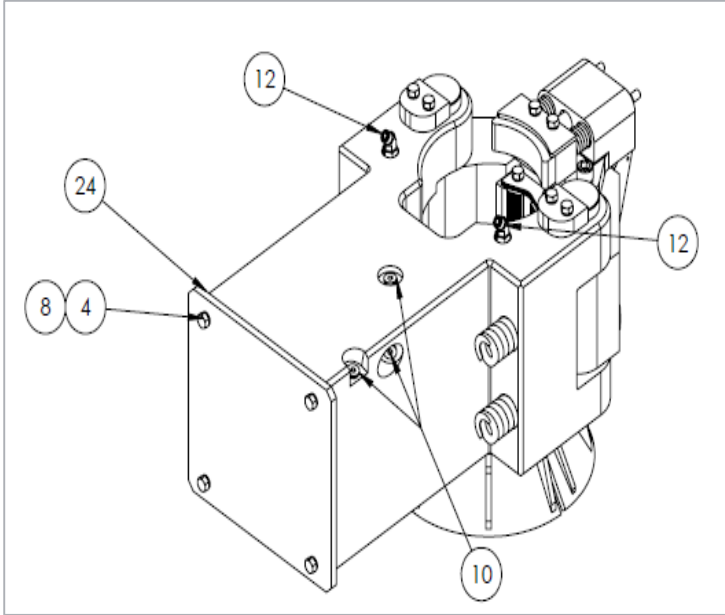
In this rendering of the original configuration, **Item 24** does not come with any means of secondary retention.

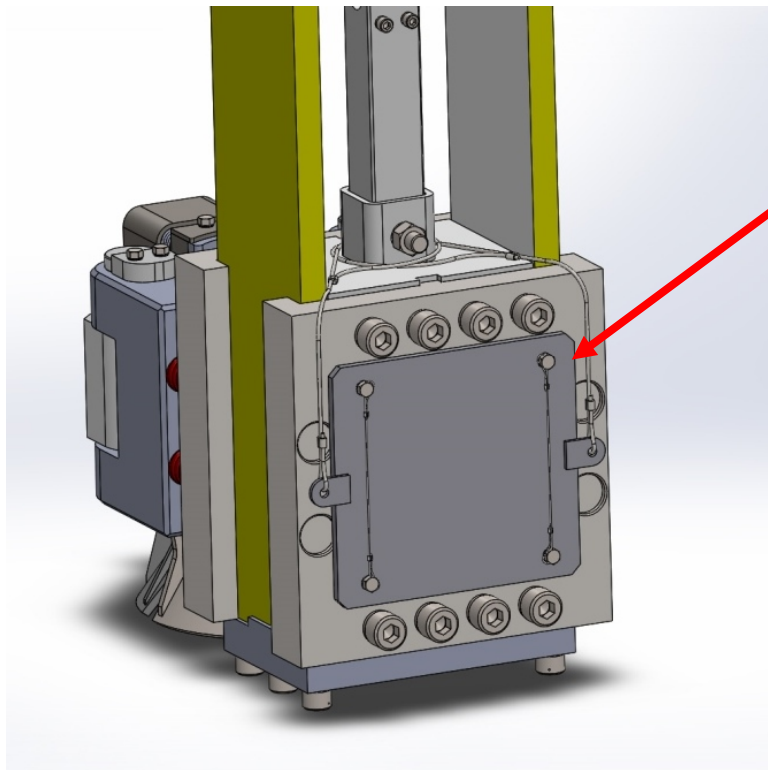
A100807 Secondary Restraint Kit installed on GDM Grabber Assembly

A secondary restraint kit (P/N A100807) has been developed and is available from GDS. Customers should order this kit to ensure the correct secondary retention parts are used.
