# SAFETY ALERT

Product Safety Bulletin No. 5

**Loosening or breaking of fasteners on brake cover.**

All GDM 500, 650, and 850 Ton Top Drives.

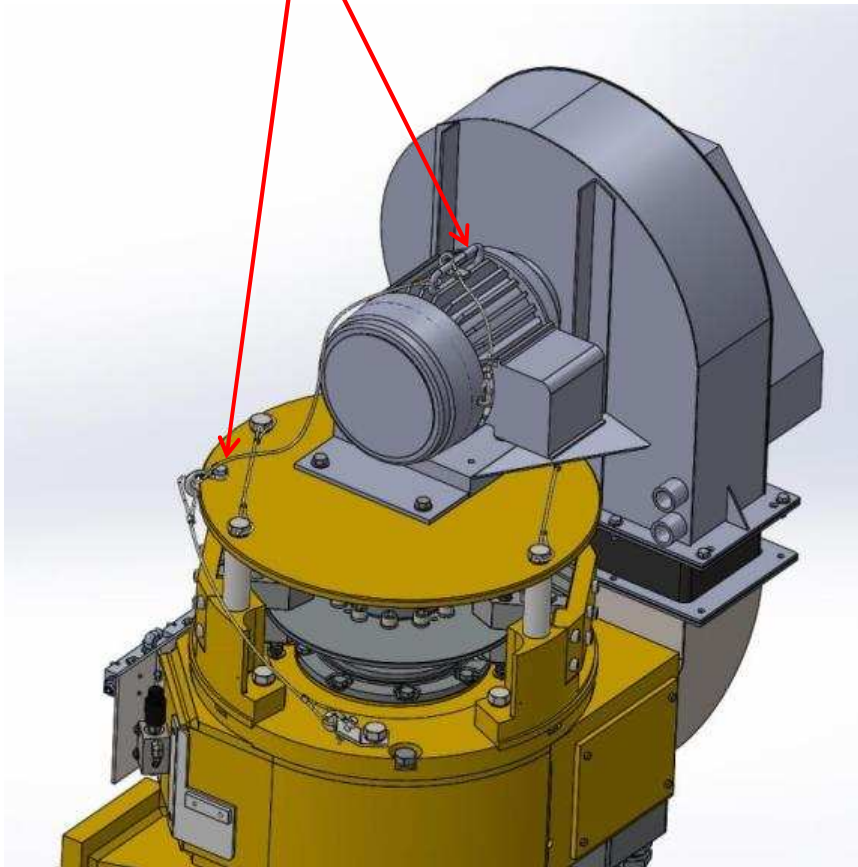
GDS received a recent report of incidents involving the 026211.12124DH2 (cap screw, socket head) coming loose or breaking.

Pictured below is the blower assembly and brake cover with secondary restraint from the A100813 kit.

GDS recommends inspecting the disc brake cover, cap screws, and lock washers on all units regularly under normal drilling and more frequently under rough drilling or jarring. If anything is found missing, it is important to replace and re-secure. If broken wires are found, check the affected bolt for tightness and rewire. If it is determined that more immediate repairs are required, please contact the GDS Service Department.

A secondary restraint kit A100813 has been developed and is available through GDS. Customers should order this kit to ensure the correct secondary retention parts are used. To facilitate the kit, a 3/4" hole will need to be drilled in the brake cover. The hole will be such that the majority of the slack is removed from the secondary restraint cable.
