# SAFETY ALERT

## Product Safety Bulletin No. 6

All GDM 500/650 and 750/850 Ton Top Drives

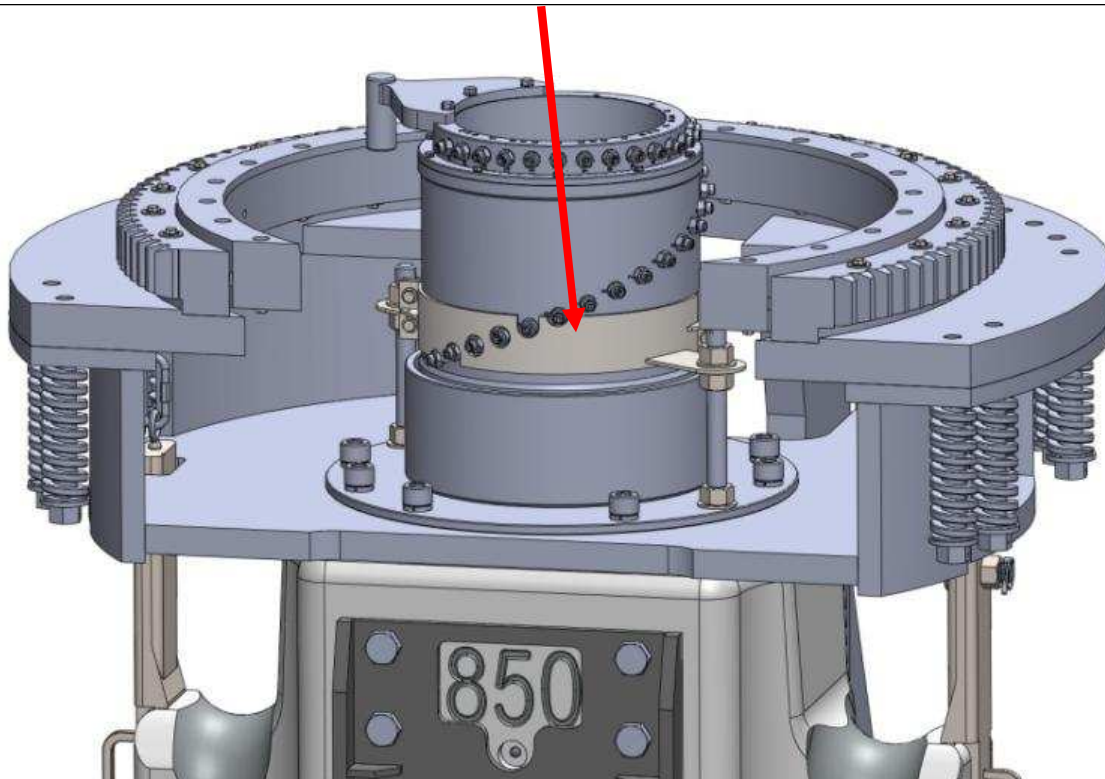
## Install the Rotary Manifold Anti-rotation Clamp A500441 / A800044

Depicted below is the 850 Ton configuration. The 500/650 ton model are very similar. The arrow shows the location of the Rotary Manifold Anti-rotation clamp.

GDS recommends installing either kit A500441 or A800044 (depending on top drive model) to insure that the rotary seal is able to swivel as required. If it is determined that more immediate repairs are required, please contact the GDS Service Department.
