# SAFETY ALERT

Product Safety Bulletin No. 7

**Fasteners breaking on Grabber Cylinder**

All GDM 850 Ton Top Drives

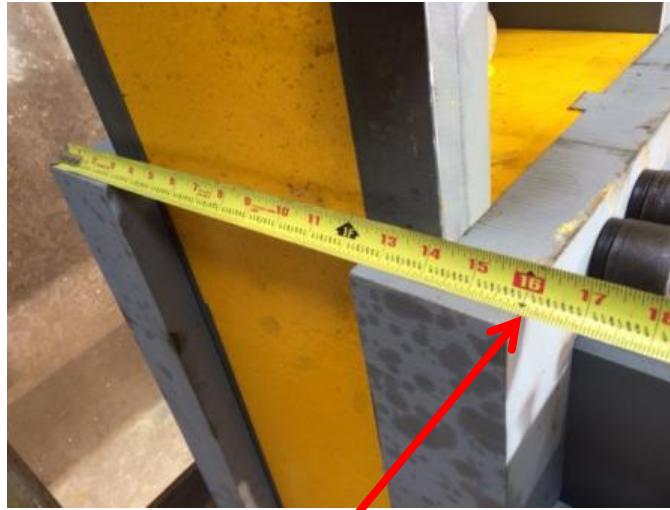
Both of these breakages were due to the Grabber Assembly Torque Box Side Plates (M800130) being machined too thick and creating a gap between the Grabber Cylinder (M800546) and the Backup Wrench Weldment (M800113).

Measurement of the overall distance between the Grabber Torque Box Top (M800167) and Grabber Torque Box Bottom (M800128).

GDS recommends inspecting the two assemblies (A800345 and A800029) to insure the assembly has the proper height stack up. This is can be done by measuring the distance between the Grabber Assembly Torque Box Side Plates (M800130).The correct measurement is 16”

If there is a discrepancy, GDS recommends replacing the Grabber Assembly Torque Box Side Plates (M800130). If it is determined that more immediate repairs are required, please contact the GDS Service Department.
