SAFETY ALERT

Product Safety Bulletin No. 8

650 Ton Top Drive

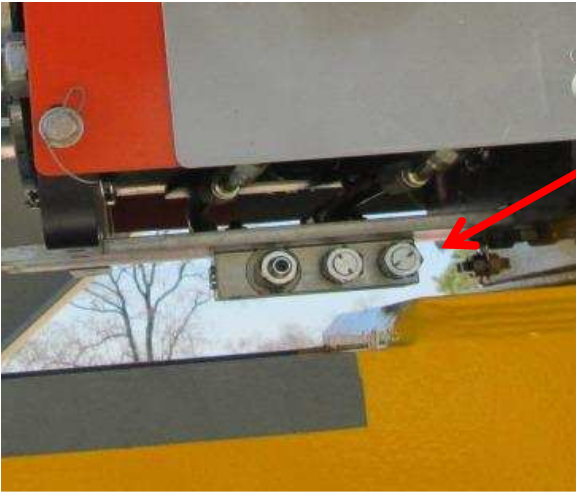
It has also been observed that the hydraulic manifold mounted on the lower well control valve actuator could come into contact with the torque arrestor.

During periods of rough drilling, it has been observed that the anti-rotation device could slide together and allow the valve mounted on the actuator to contact with the BUW wrench weldment and cause wear to the valve body.

The current configuration showing the location of hydraulic manifold assembly (A100181) on lower well control valve actuator.

GDS recommends inspecting the hydraulic manifold assembly for possible damage and relocating it to the BUW weldment assembly.

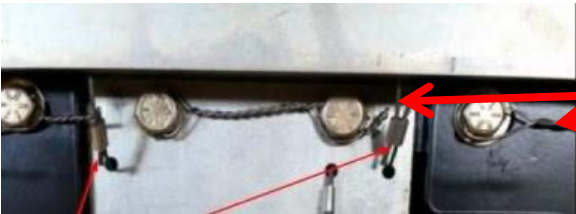
It has been observed that the bolts that position the anti-rotation brackets on the GDM 650 Ton Top Drive could come loose and allow the bracket to become out of adjustment.

Actuator anti-rotation plate safety wiring.
Safety wire applied to fasteners

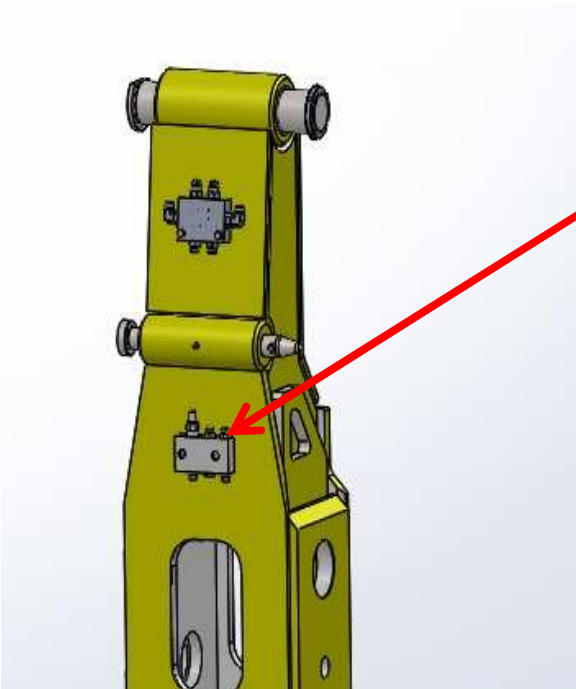
The new configuration showing the valve relocated to the BUW weldment using relocation kit (GDS P/N A600019).

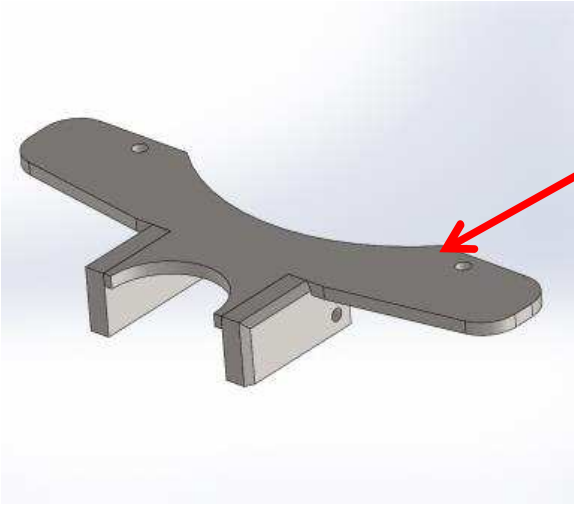
Part M500748, anti-rotation weldment, is available as a part of A600012 rev 02 kits.

GDS further recommends replacing the current anti-rotation assembly with A600012 rev. 02, which will better allow for movement during any rough drilling period.

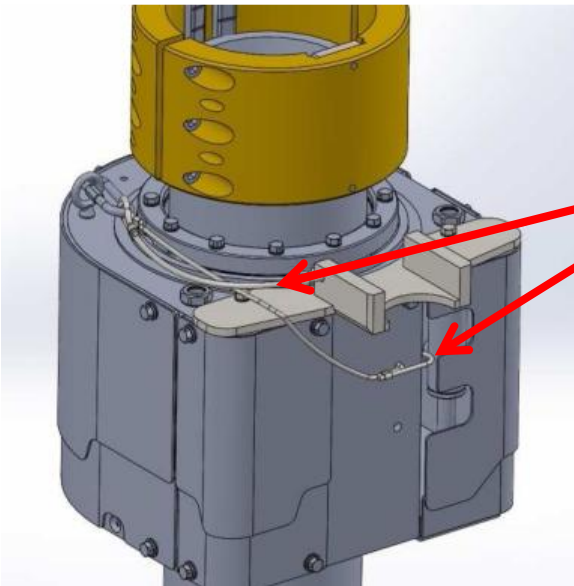
Safety cable to anti-rotation weldment.

Safety cable added to actuator slide
